Tree Risk Assessment of White Oak Hunnewell Elementary School 28 Cameron St, Wellesley, MA 02482

December 18, 2019

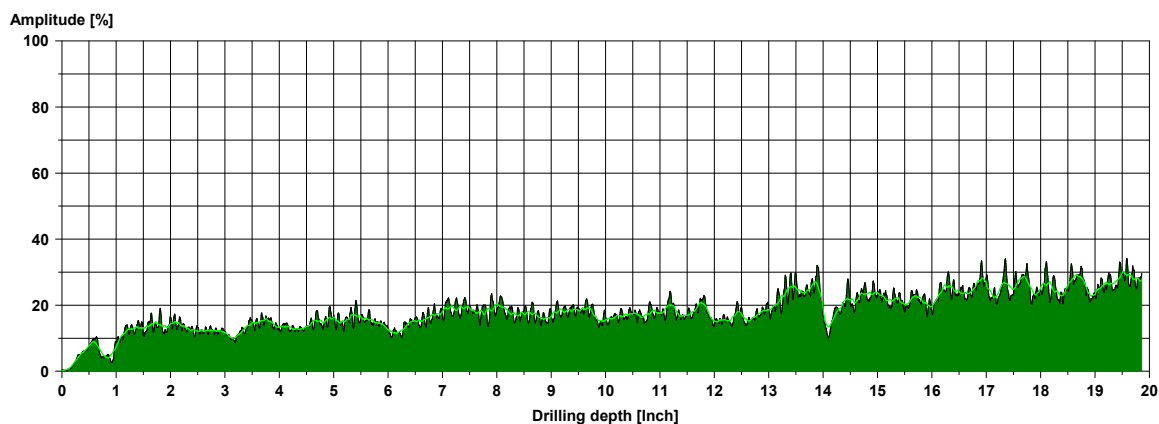
Measurement01.rgp

Measurement no. :	1	Needle speed :	3000 r/min	Diameter :	50.0 "
ID number :	Trunk 1	Needle state :	---	Level :	48.0 "
Drilling depth :	19.858 "	Tilt :	0°	Direction :	W
Date :	18.12.2019	Offset :	68/331	Species :	Quercus alba
Time :	12:40:32	Avg. curve :	50 values	Location :	Trunk
Feed speed :	20 "/min	Name :

Sound wood throughout.

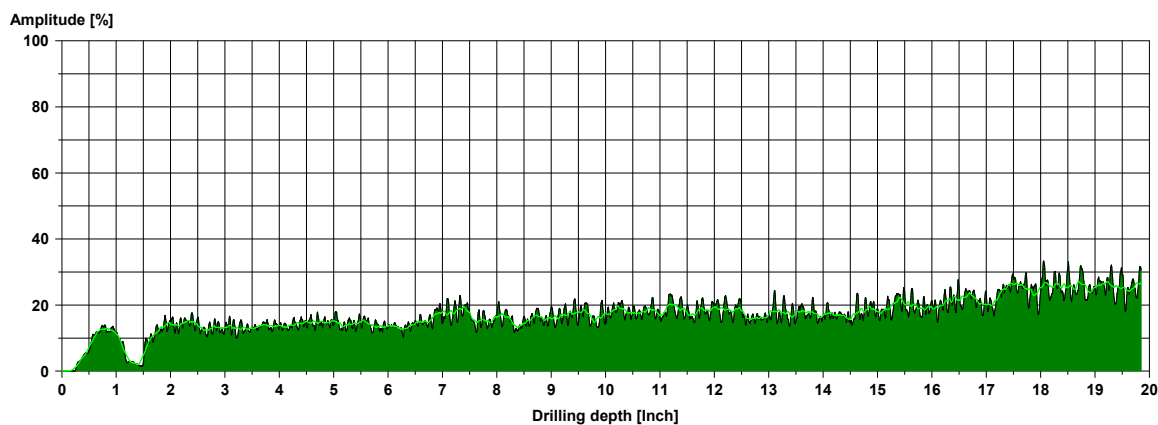
Measurement02.rgp

Measurement no. :	2	Needle speed :	3000 r/min	Diameter :	50.0 "
ID number :	Trunk 2	Needle state :	---	Level :	48.0 "
Drilling depth :	19.850 "	Tilt :	0°	Direction :	N
Date :	18.12.2019	Offset :	64/314	Species :	Quercus alba
Time :	12:42:31	Avg. curve :	50 values	Location :	Trunk
Feed speed :	20 "/min			Name :

Sound wood throughout.
 Initial dips represent passing through the bark.

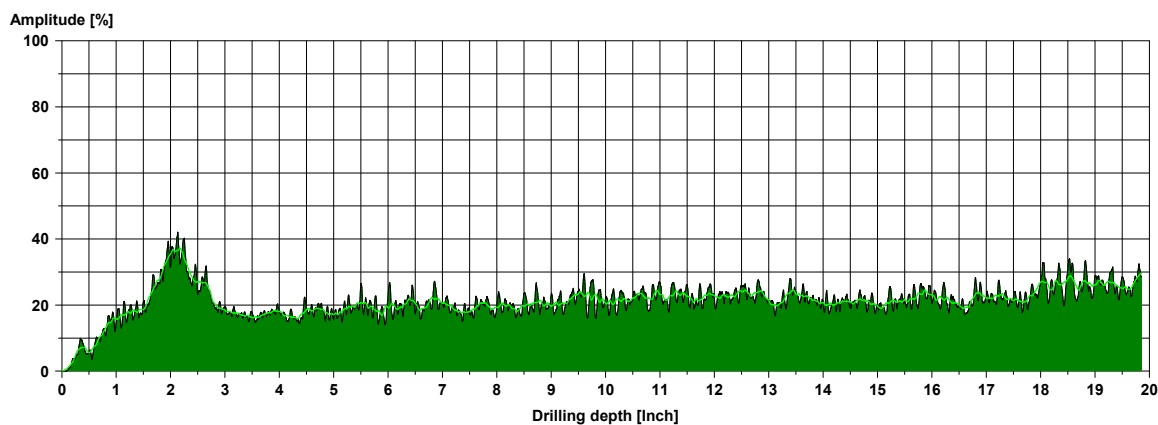
Measurement03.rgp

Measurement no. :	3	Needle speed :	3000 r/min	Diameter :	50.0 "
ID number :	Trunk 3	Needle state :	---	Level :	48.0 "
Drilling depth :	19.854 "	Tilt :	0°	Direction :	E
Date :	18.12.2019	Offset :	64/311	Species :	Quercus alba
Time :	12:44:29	Avg. curve :	50 values	Location :	Trunk
Feed speed :	20 "/min			Name :

Sound wood throughout.
 Peak at 2 inches represents passing an old wound where callus is present. Calluses tend to be more dense.

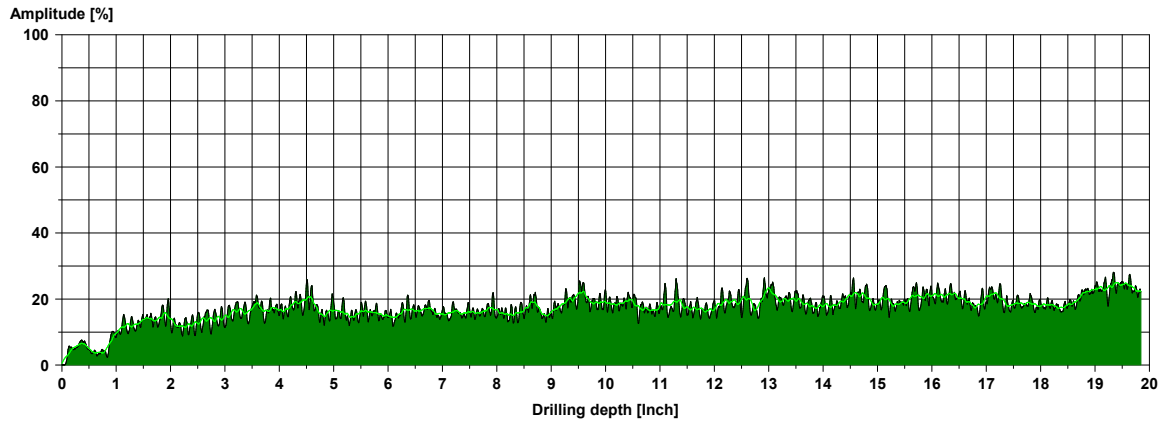
Measurement04.rgp

Measurement no. :	4	Needle speed :	3000 r/min	Diameter :	50.0 "
ID number :	Trunk 4	Needle state :	---	Level :	48.0 "
Drilling depth :	19.846 "	Tilt :	0°	Direction :	S
Date :	18.12.2019	Offset :	66/311	Species :	Quercus alba
Time :	12:46:09	Avg. curve :	50 values	Location :	Trunk
Feed speed :	20 "/min			Name :

Sound wood throughout.

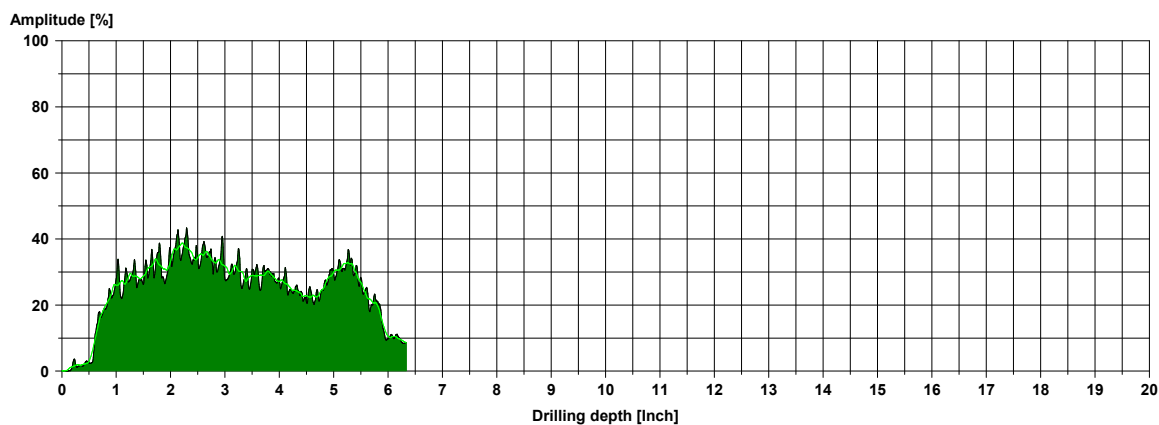
Measurement05.rgp

Measurement no. :	5	Needle speed :	3000 r/min	Diameter :	6,5 "
ID number :	Root 1	Needle state :	---	Level :	4,0 "
Drilling depth :	6,335 "	Tilt :	-65°	Direction :	W
Date :	18.12.2019	Offset :	40/307	Species :	Quercus alba
Time :	12:48:06	Avg. curve :	50 values	Location :	Roots
Feed speed :	20 "/min			Name :

Sound wood throughout.

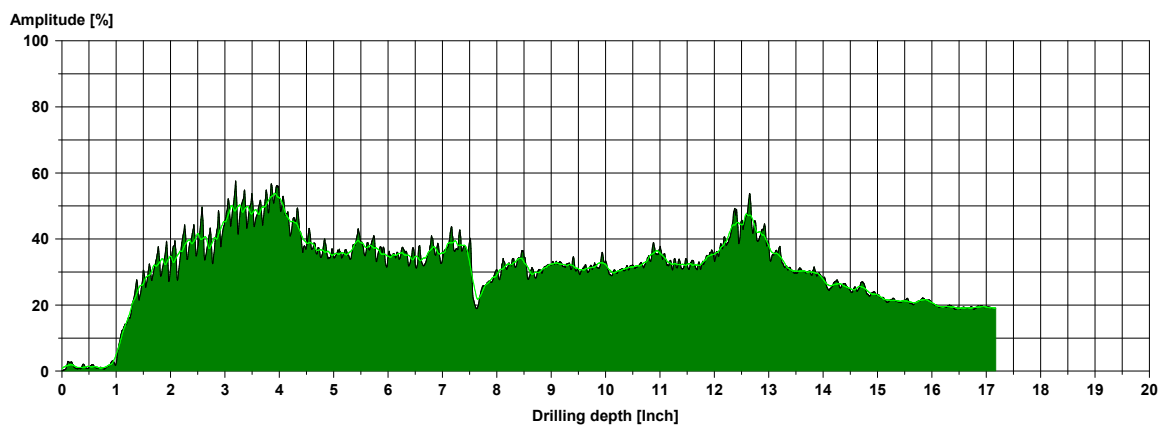
Measurement06.rgp

Measurement no. :	6	Needle speed :	3000 r/min	Diameter :	17.5 "
ID number :	Root 2	Needle state :	---	Level :	4.0 "
Drilling depth :	17.173 "	Tilt :	-59°	Direction :	N
Date :	18.12.2019	Offset :	43/307	Species :	Quercus albas
Time :	12:49:08	Avg. curve :	50 values	Location :	Roots
Feed speed :	20 "/min			Name :

Sound wood throughout with a slight dip at 7.5".

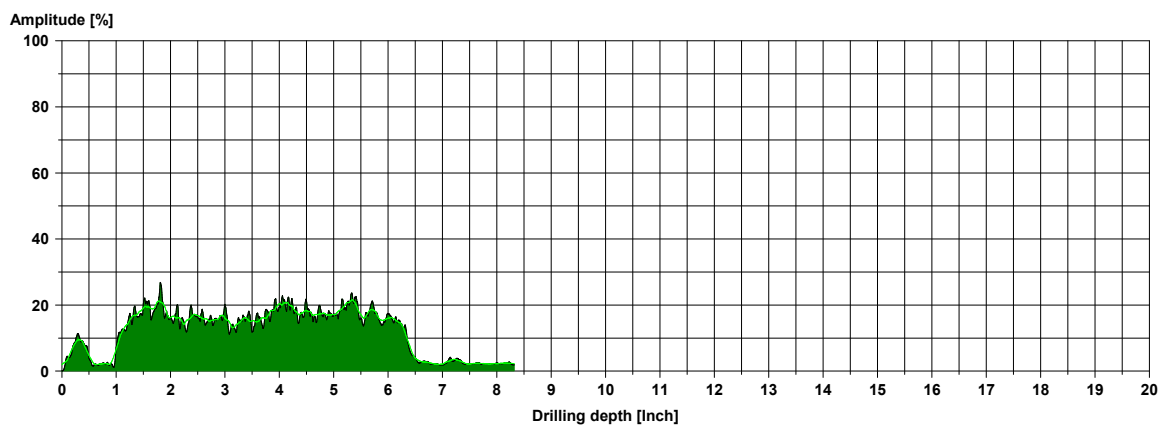
Measurement07.rgp

Measurement no. :	7	Needle speed :	3000 r/min	Diameter :	6,5 "
ID number :	Root 3	Needle state :	---	Level :	4,0 "
Drilling depth :	8,319 "	Tilt :	-56°	Direction :	E
Date :	18.12.2019	Offset :	42/302	Species :	Quercus albas
Time :	12:50:40	Avg. curve :	50 values	Location :	Roots
Feed speed :	20 "/min			Name :

A slight bit of insipid decay from .5-1". Sound throughout the rest.

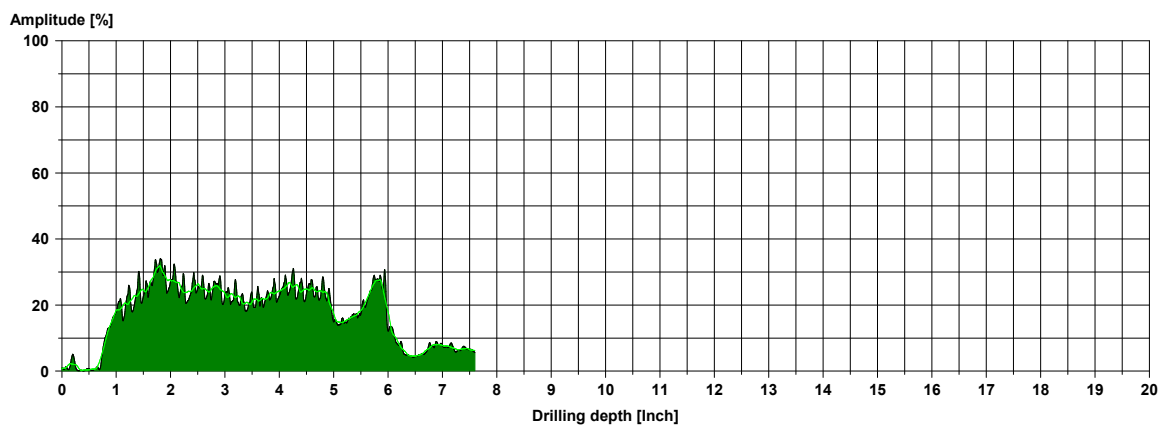
Measurement08.rgp

Measurement no. :	8	Needle speed :	3000 r/min	Diameter :	7,5 "
ID number :	Root 4	Needle state :	---	Level :	4,0 "
Drilling depth :	7,598 "	Tilt :	-65°	Direction :	S
Date :	18.12.2019	Offset :	45/472	Species :	Quercus alba
Time :	12:51:27	Avg. curve :	50 values	Location :	Roots
Feed speed :	20 "/min			Name :

Some decay at the root surface then again at 6".
 Only slight decay.

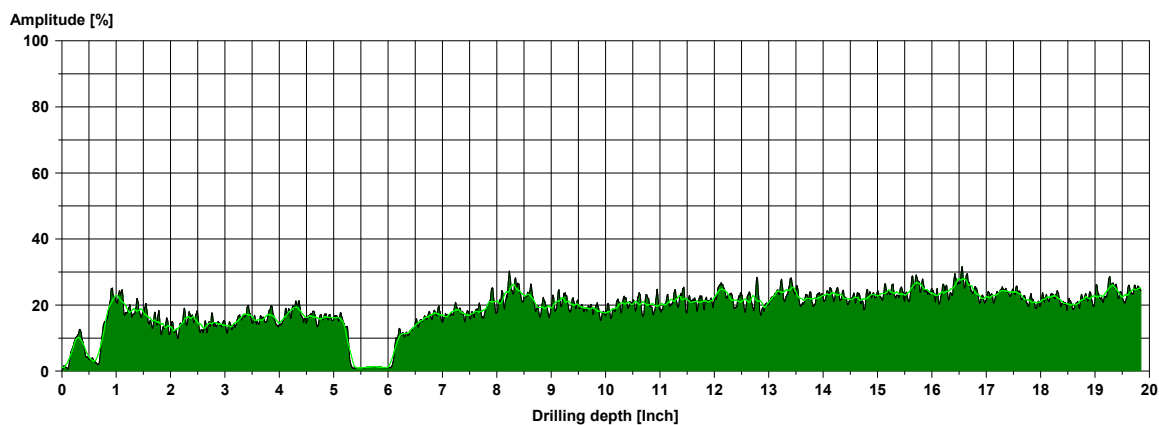
Measurement09.rgp

Measurement no. :	9	Needle speed :	3000 r/min	Diameter :	50.0 "
ID number :	Across Crack	Needle state :	---	Level :	30.0 "
Drilling depth :	19.846 "	Tilt :	-16°	Direction :	NW
Date :	18.12.2019	Offset :	61/305	Species :	Quercus alba
Time :	12:52:31	Avg. curve :	50 values	Location :	Trunk
Feed speed :	20 "/min			Name :	Crack

Sound wood is present throughout with the exception of the crack.

The drop at from 5.5 to 6 inches represents the crack, not decay or a cavity.

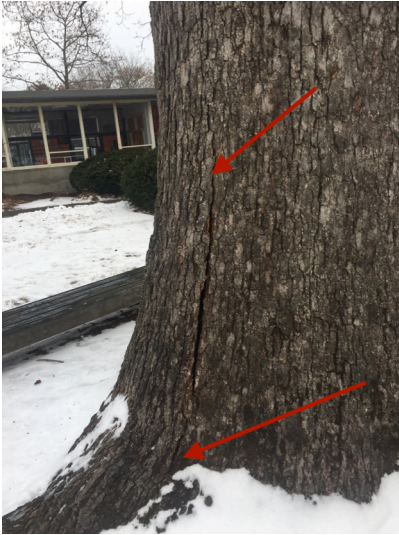
Photo 1

- A large, open crack is present on the west side of the tree, starting at the ground running up the trunk approximately 3 feet (See Photos 1-4, page #16).
- Several cracks are forming on the south and southwest side of the tree, evidenced by fissures in the bark (See Photo 5, page #17).
- Old pruning cuts are not forming healthy calluses thus not compartmentalizing well (See Photo 6, page #17).
- Cavities are present in the limbs of the tree (See Photos 7 & 8, page #17).
- Branch unions with included bark are present (See Photo 9, page #18).
- Several major limbs are developing stress crack due to overloading (See Photo 10, page #18).
- The tree has a lean to the east, towards the school entrance, and is lacking supporting buttress roots on that side if the tree (See Photos 11 & 12, page #18).

- A large, open crack is present on the west side of the tree, starting at the root and running up the trunk approximately 3 feet – **This is a major concern, cracks of this nature can severely comprise the structural integrity of the tree. Cracks like this typically continue to get larger with tree growth until the tree's threshold for supporting its own weight is surpassed and the entire tree fails.**

It is our recommendation that the 50" DBH *Quercus alba* in the courtyard of the Hunnewell Elementary School be removed immediately. Due to the foot traffic and proximity to the building it present a High Risk to public safety.
